East Alaska Lake, Wisconsin

The Path to a Successful Lake Restoration

Beginning the Process with Baseline Studies and Creating a Management Plan

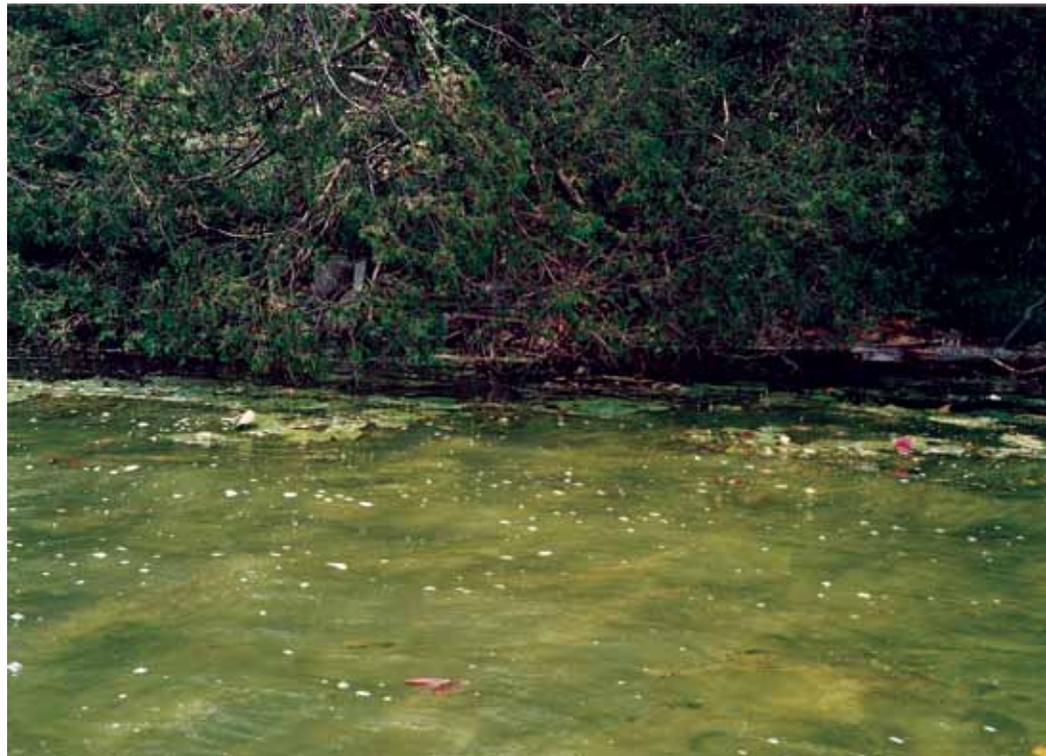
Figure 1. Algae bloom on East Alaska Lake. Photo by Patrick Robinson.

The studies associated with that first planning project confirmed the concerns over poor water quality raised by East Alaska Lake stakeholders, including eutrophic conditions brought on by high nutrient levels that resulted in frequent pelagic and filamentous algae blooms (Figure 1). Documentation of the lake's poor water quality conditions continued into the 2000s with summer phosphorus levels often exceeding 0.030 mg/L, which is higher than the median value of 0.017 mg/L for deep, headwater drainage lakes in Wisconsin (WDNR 2009).

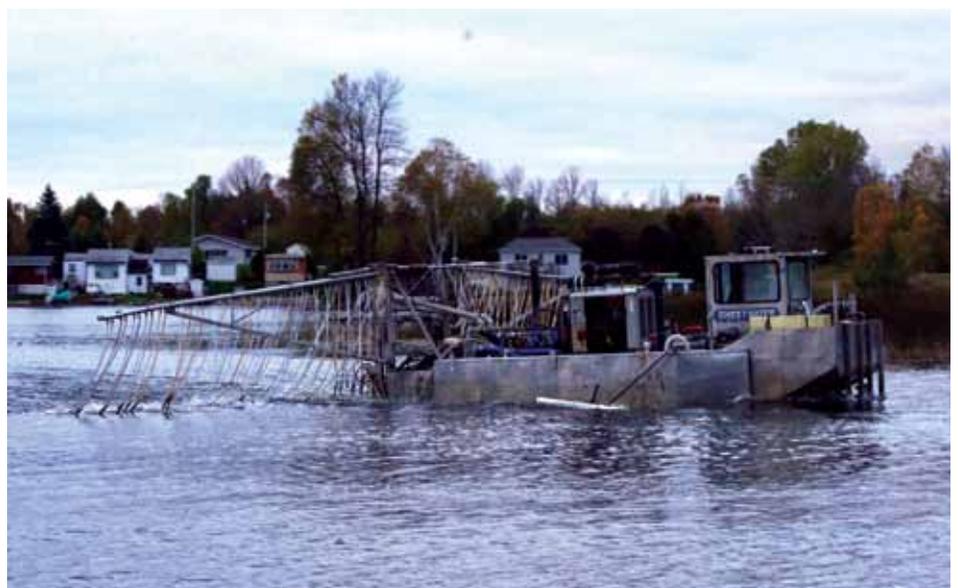
Figure 3. Barge applying alum to East Alaska Lake during October 2011.

After 20-plus years of study and planning, the East Alaska Lake alum treatment was implemented in mid-October 2011 and included the application of nearly 84,000 gallons of aluminum sulfate over a two-day period (Figure 3). It is quite a spectacle to have a 24-foot stainless steel barge with a 60-foot boom span sweep back and forth across a 53-acre lake. Add in a constant convoy of tanker trucks bringing aluminum sulfate to the lake's small landing and the characteristic milky turquoise appearance of the lake water during application (Figure 4) and you have something people are likely to go out of their way to see.

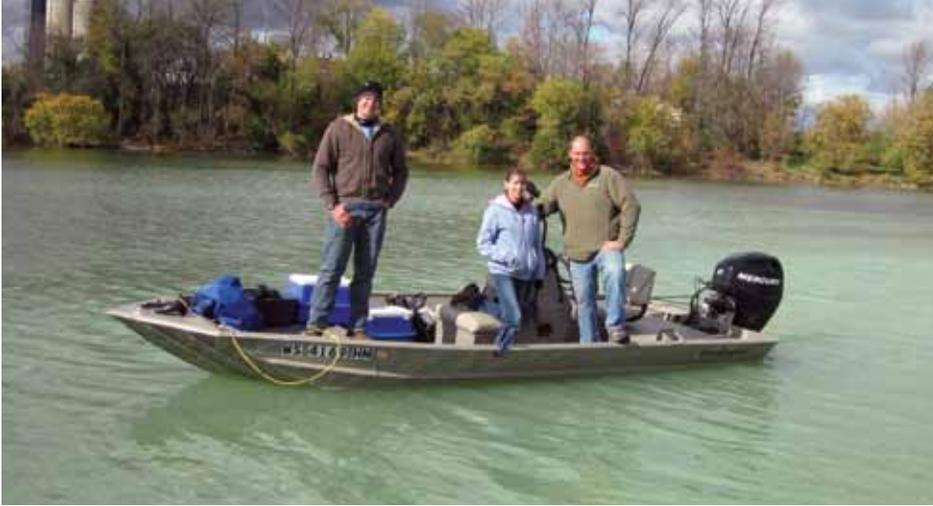
Figure 4. Treatment monitoring crew on East Alaska Lake. Notice the milky turquoise water resulting from the alum treatment occurring that day.

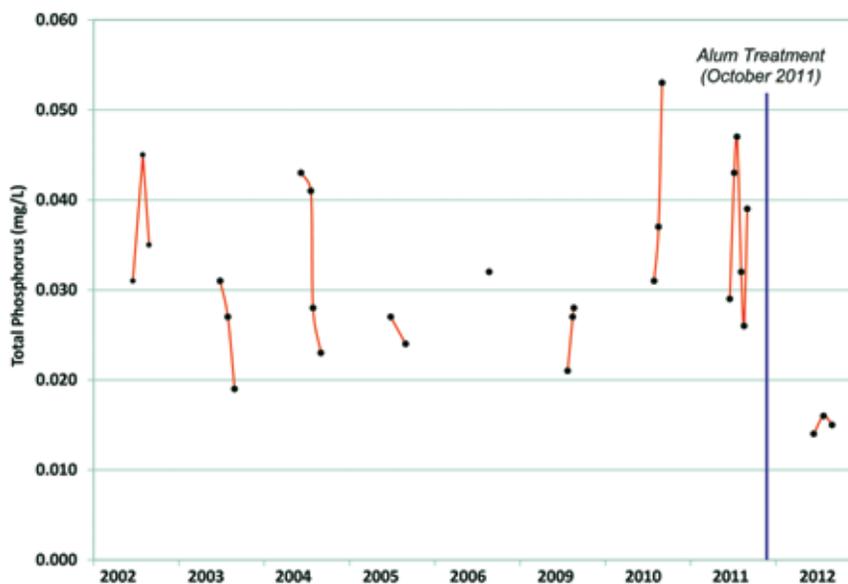
Figure 6. East Alaska Lake summer (June, July, and August) near-surface total phosphorus concentrations from 2002-2012. The alum treatment occurred during October 2011.

A single growing season's data have been collected at East Alaska Lake post alum treatment. Casual observations throughout the summer were positive as no filamentous algae was noted and near surface total phosphorus values were lower than previously measured (Figure 6). During early fall 2012, a core was extracted from the deep hole where the full dose rate of 132 g/m² was applied, a distinct layer was found near the surface of the sediment, indicating a substantial barrier to sediment phosphorus flux had been created (Figure 7). A phosphorus profile collected during the same October visit is also strong evidence of the success of the treatment, especially when compared to profiles collected the two previous years (Figure 8). During the two years prior to the treatment, total phosphorus concentrations in the anoxic hypolimnion ranged from 0.1 to 1.24 mg/L, while the post treatment samples spanned from 0.040 to 0.088 mg/L.

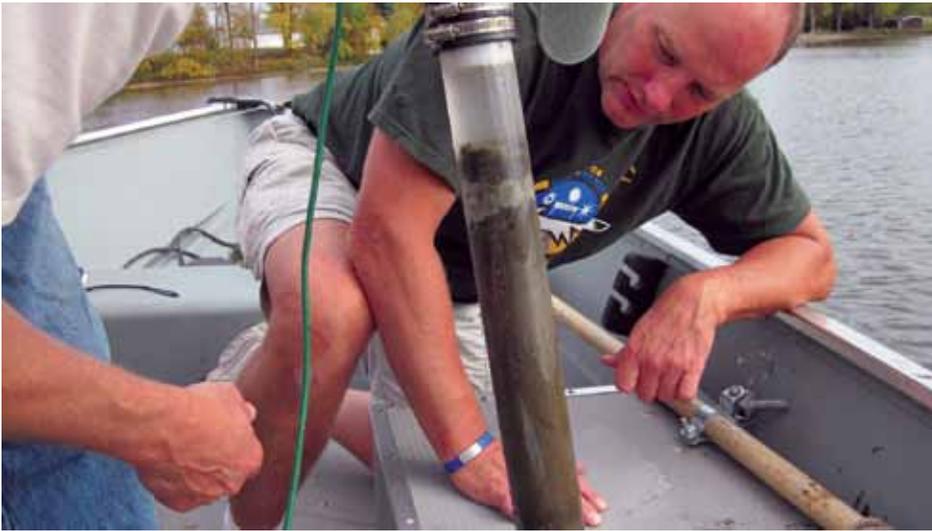
Figure 7. Bottom core extracted from the deepest location in East Alaska Lake approximately one year after the alum treatment. The white section is the alum layer that has settled approximately two inches into the soft bottom sediments.
